# TECHNICAL NOTE

D-125

By R. A. Signorelli, J. R. Johnston, and J. W. Weeton

THERMAL-STRESS FATIGUE CRACKING OF TURBINE BUCKETS OPERATED  
AT 1700° F IN A TURBOJET ENGINE WITH  
FREQUENT STARTS AND STOPS

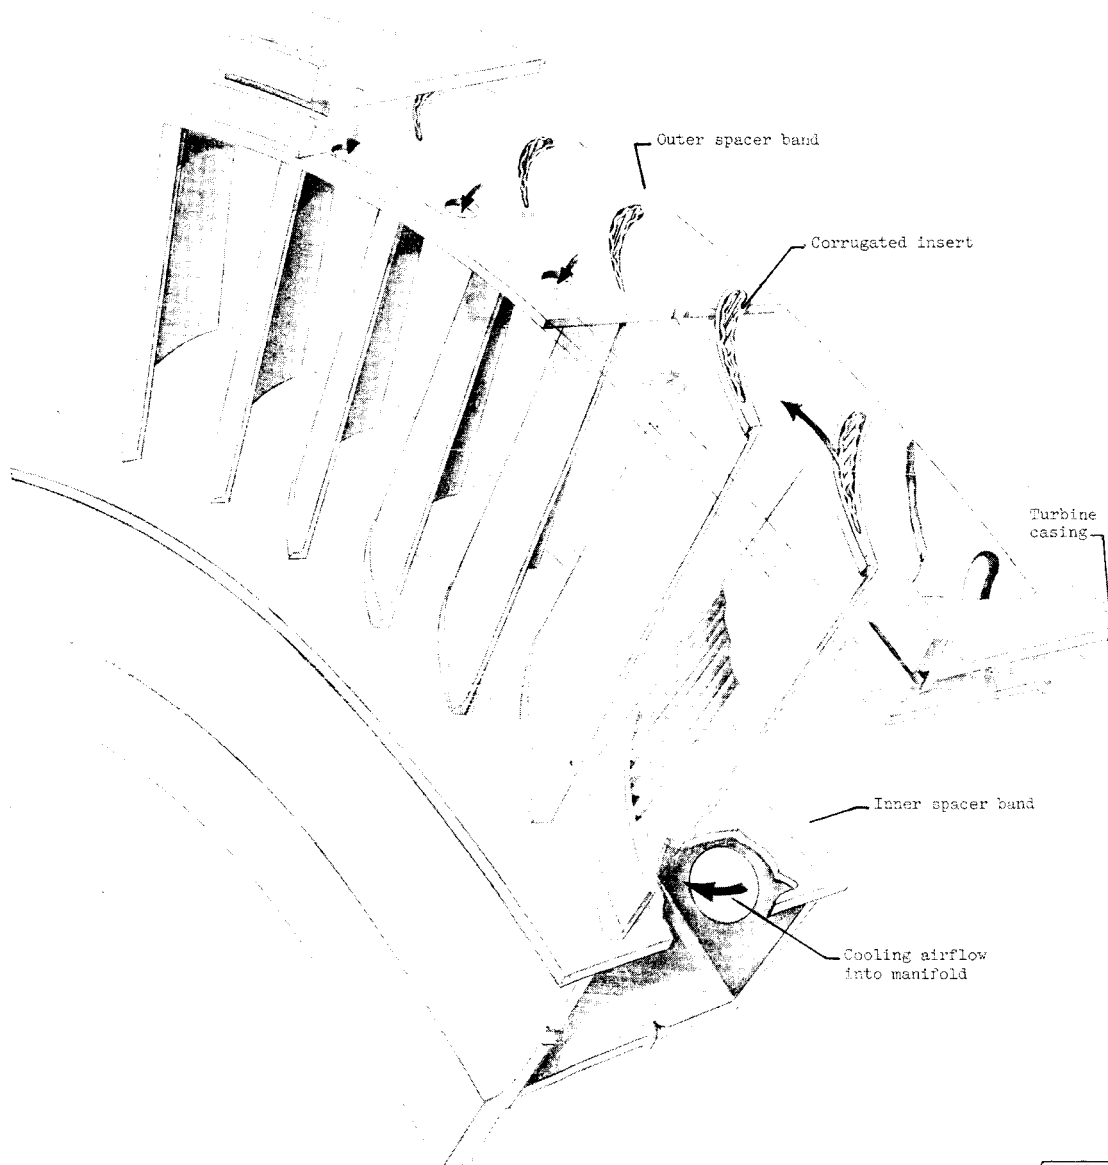
Modifications to provide cooling of turbine stator blades are illustrated in figure 1. These blades, which are normally uncooled, were cooled by air from an auxiliary source. The air was passed into a manifold welded to the inner spacer band, through the hollow blades, through holes in the outer spacer band, and into the gas stream ahead of the turbine buckets. Corrugated inserts guided the air along the inner surfaces of the stator blades for more efficient cooling. The turbine disk in a standard J47 engine is normally cooled by air bled from the compressor and directed to both upstream and downstream faces. Normally air is provided at a rate of  $1\frac{1}{2}$  pound per second to cool each disk face. An additional  $1\frac{1}{2}$  pounds per second of air was bled from the compressor to supply the added cooling needed to maintain normal operating temperatures in the disk. The additional cooling air was supplied to the downstream face by merely increasing the size of the air line. Cooling of the rim area of the upstream face of the disk was provided by bleed air ducted through an annular nozzle positioned near the upstream face.

Figure 1. - Method of cooling turbine stator blades.

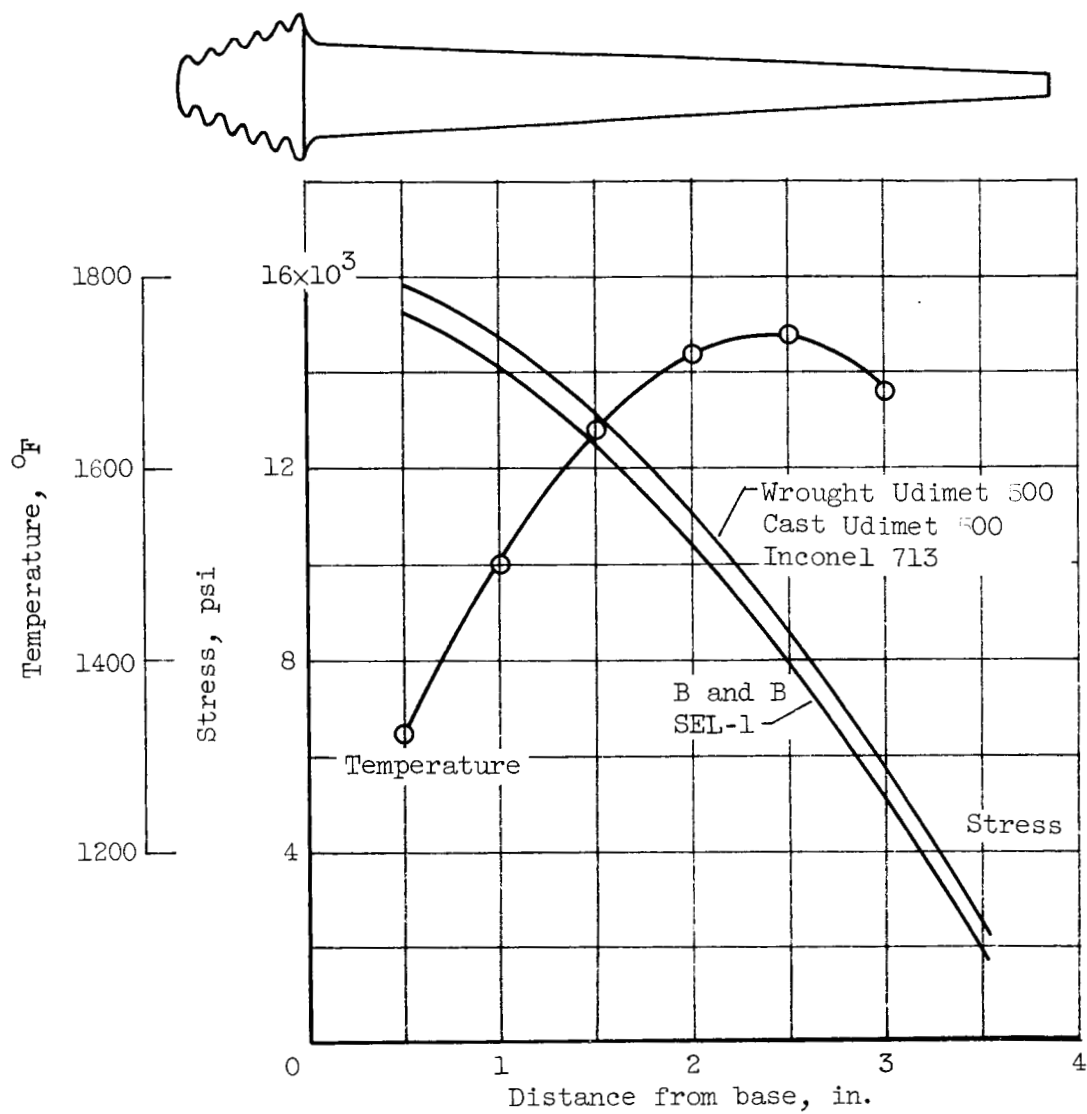
E-471 Centrifugal stress and temperature distribution in bucket airfoils at rated-speed and advanced-temperature conditions are shown in figure 2. The centrifugal stress was calculated by the method of reference 6, using the bucket geometry, material density, and engine rotational speed. The temperature distribution shown in figure 2 was obtained before the materials test was started. To do this, the engine was operated with standard S-816 alloy buckets for sufficient time to obtain equilibrium conditions at rated speed. Temperature measurements were obtained from thermocouples imbedded in four turbine buckets.

Figure 2. - Bucket stress and temperature distributions at rated conditions.

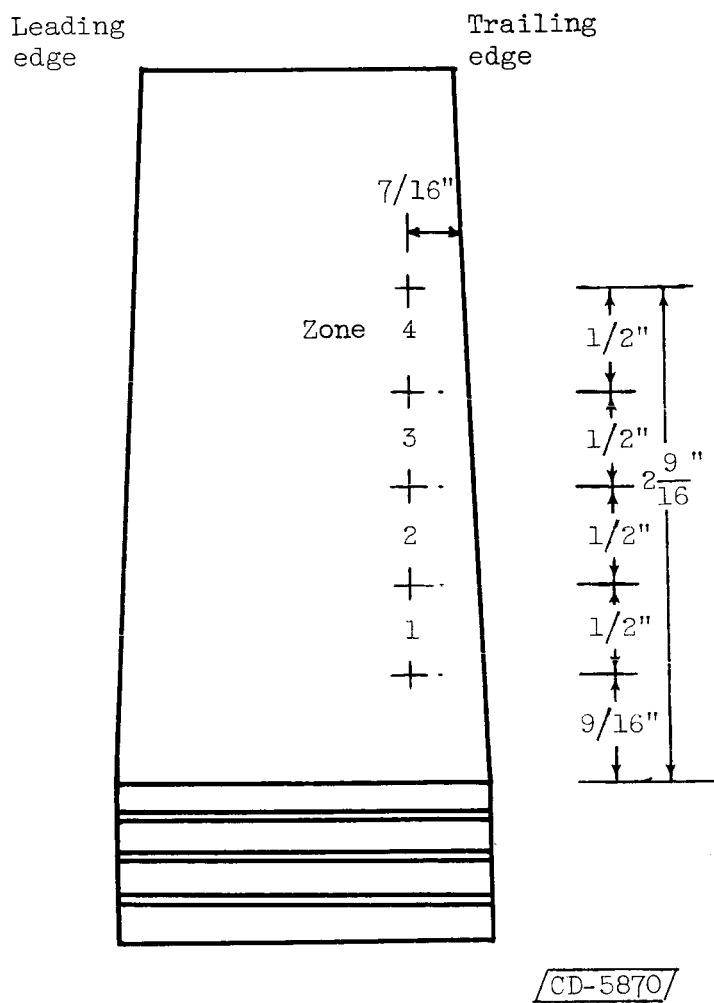
Two buckets of each alloy group were scribed for elongation measurements at 1/2-inch intervals (as shown in fig. 3). Elongation readings of scribed zones were taken at convenient time intervals and at the conclusion of the test. The measurements were made with an optical micrometer having a sensitivity of 0.0001 inch. However, because of the width of the scribe marks, bowing of bucket airfoils, and human error, elongation readings were actually significant to  $\pm 0.001$  inch or  $\pm 0.2$ -percent elongation in each 1/2-inch-gage length.

Figure 3. - Scribed bucket for elongation measurements.

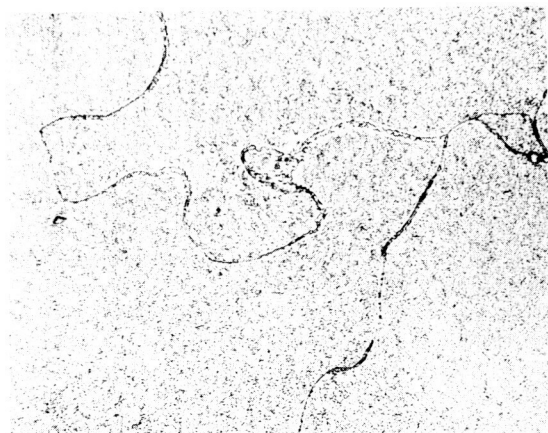
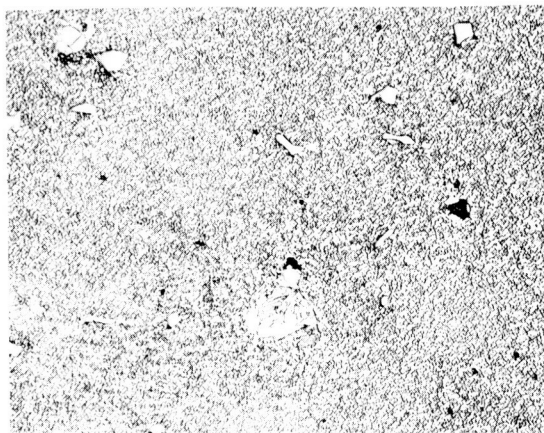
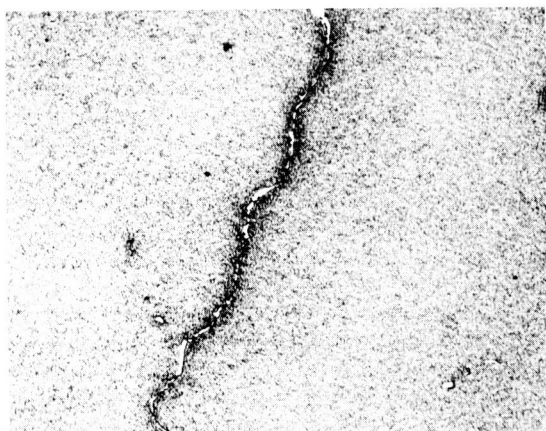
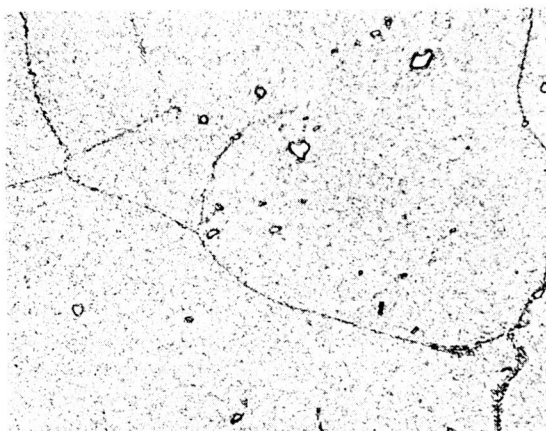
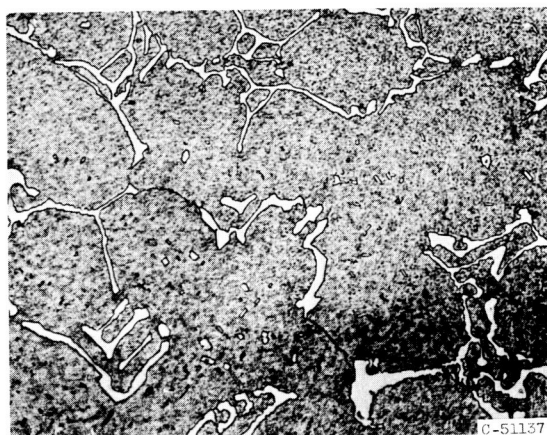
Photomicrographs of general structures of buckets of all alloy groups are shown in figure 6. All the structures appear similar, with a fine precipitation of minor phases throughout the grains, as is typical of high-temperature nickel-base alloys. No noticeable change in microstructure for any of the alloy groups was apparent after 70 hours of engine operation. Consequently, only photomicrographs of untested buckets are shown.

Figure 6. - Typical microstructures of buckets. Etchant: 10 percent HF, 20 percent  $\text{HNO}_3$ . X750.
